Recent History of Glacial Lake Outburst Floods, Analysis of Channel Changes, and Development of a Two-Dimensional Flow and Sediment Transport Model of the Snow River near Seward, Alaska

Scientific Investigations Report 2022–5099

By Robin A. Beebee

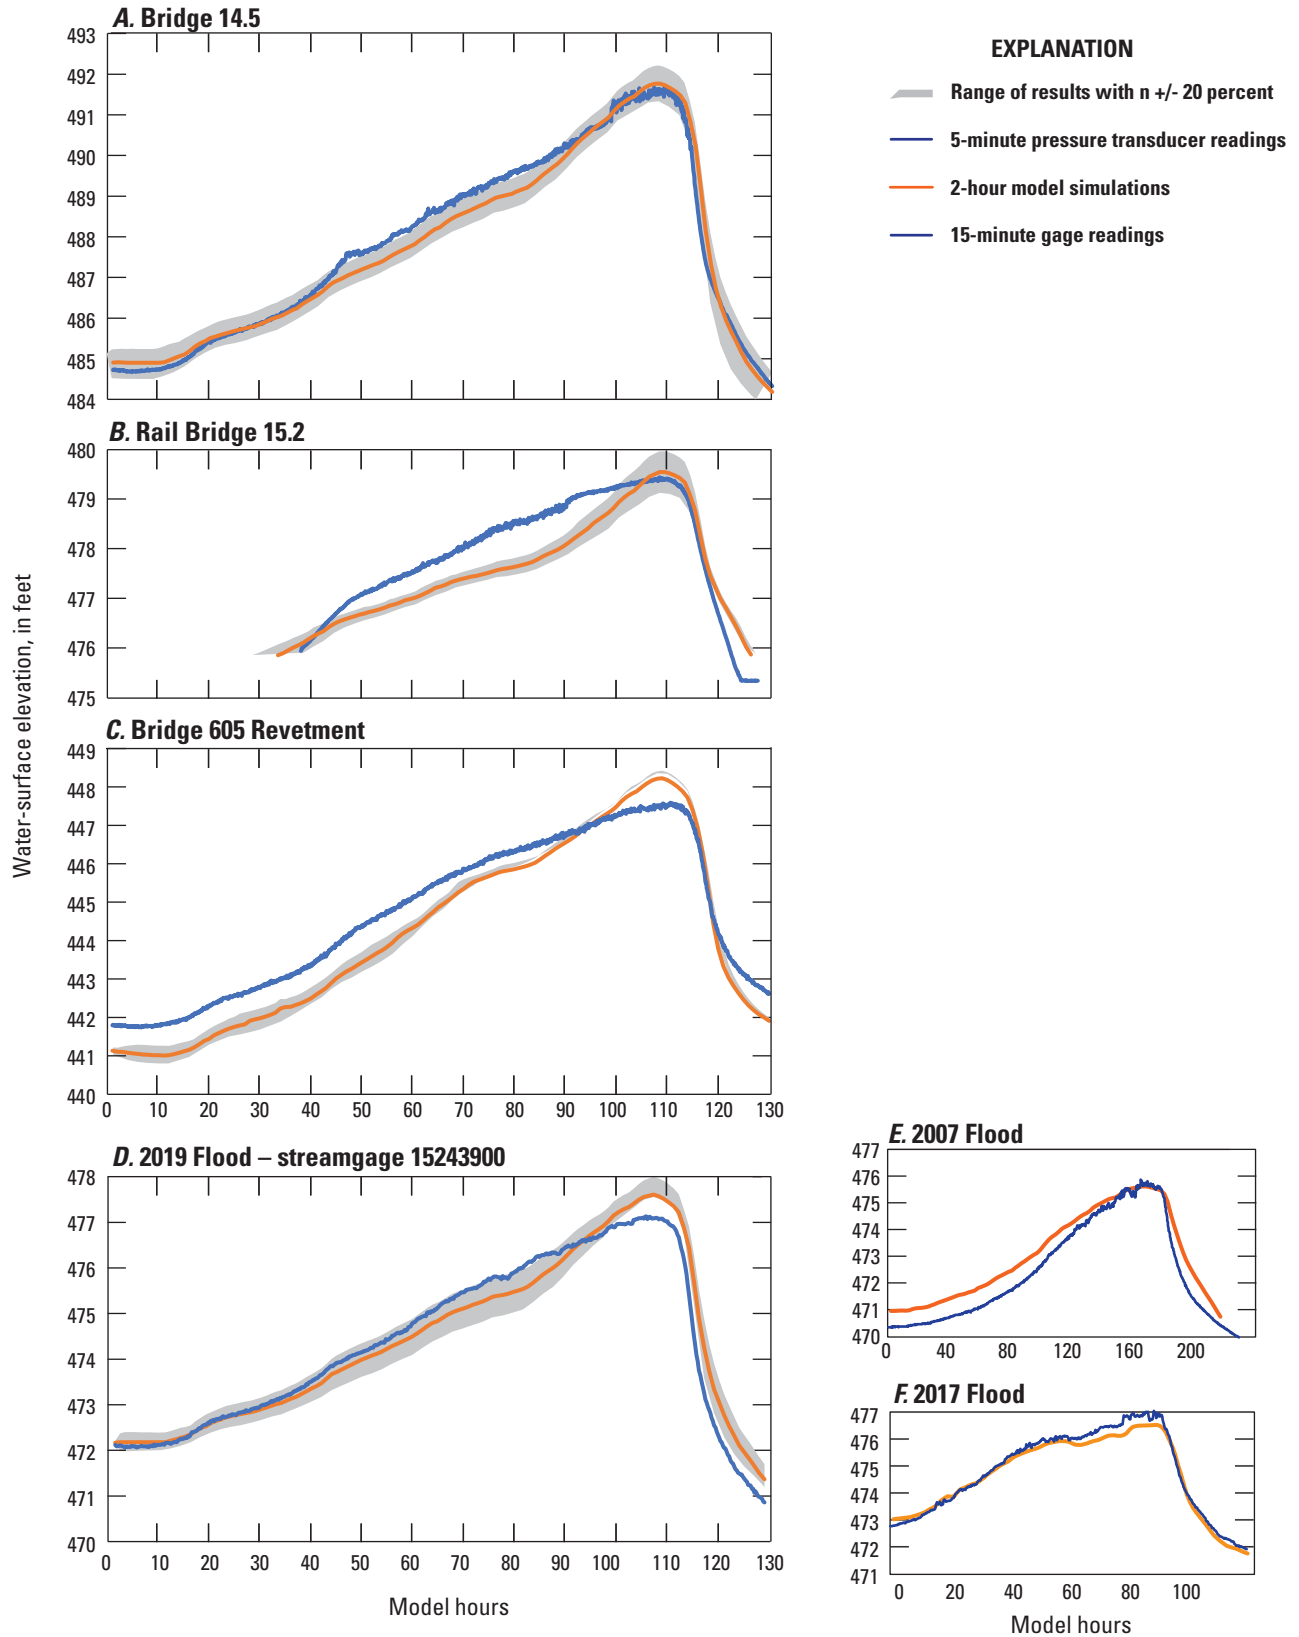
Figure 18. Pressure transducer and streamgage water surface records during the 2019 flood compared to model simulations. Inset box shows streamgage comparisons for 2007 and 2017 outburst floods, near Seward, Alaska. Measurement locations shown in figure 2.

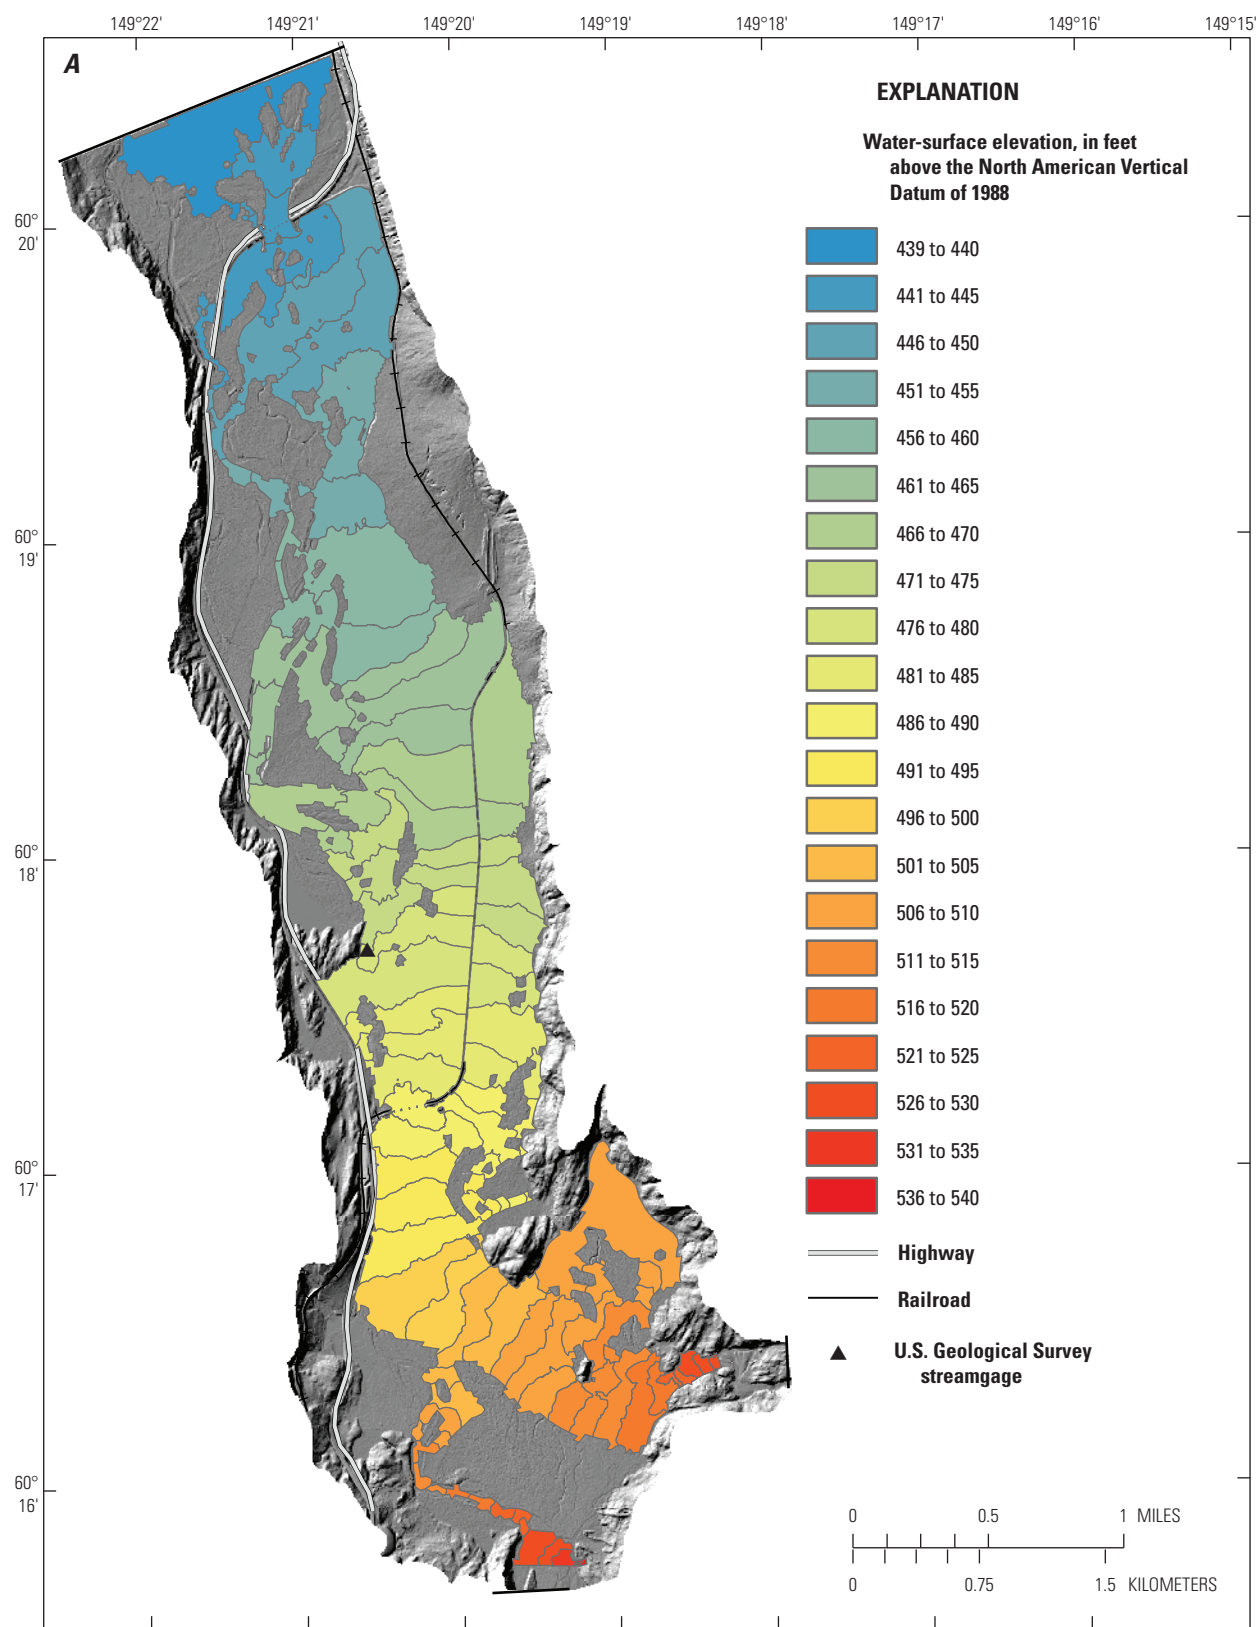
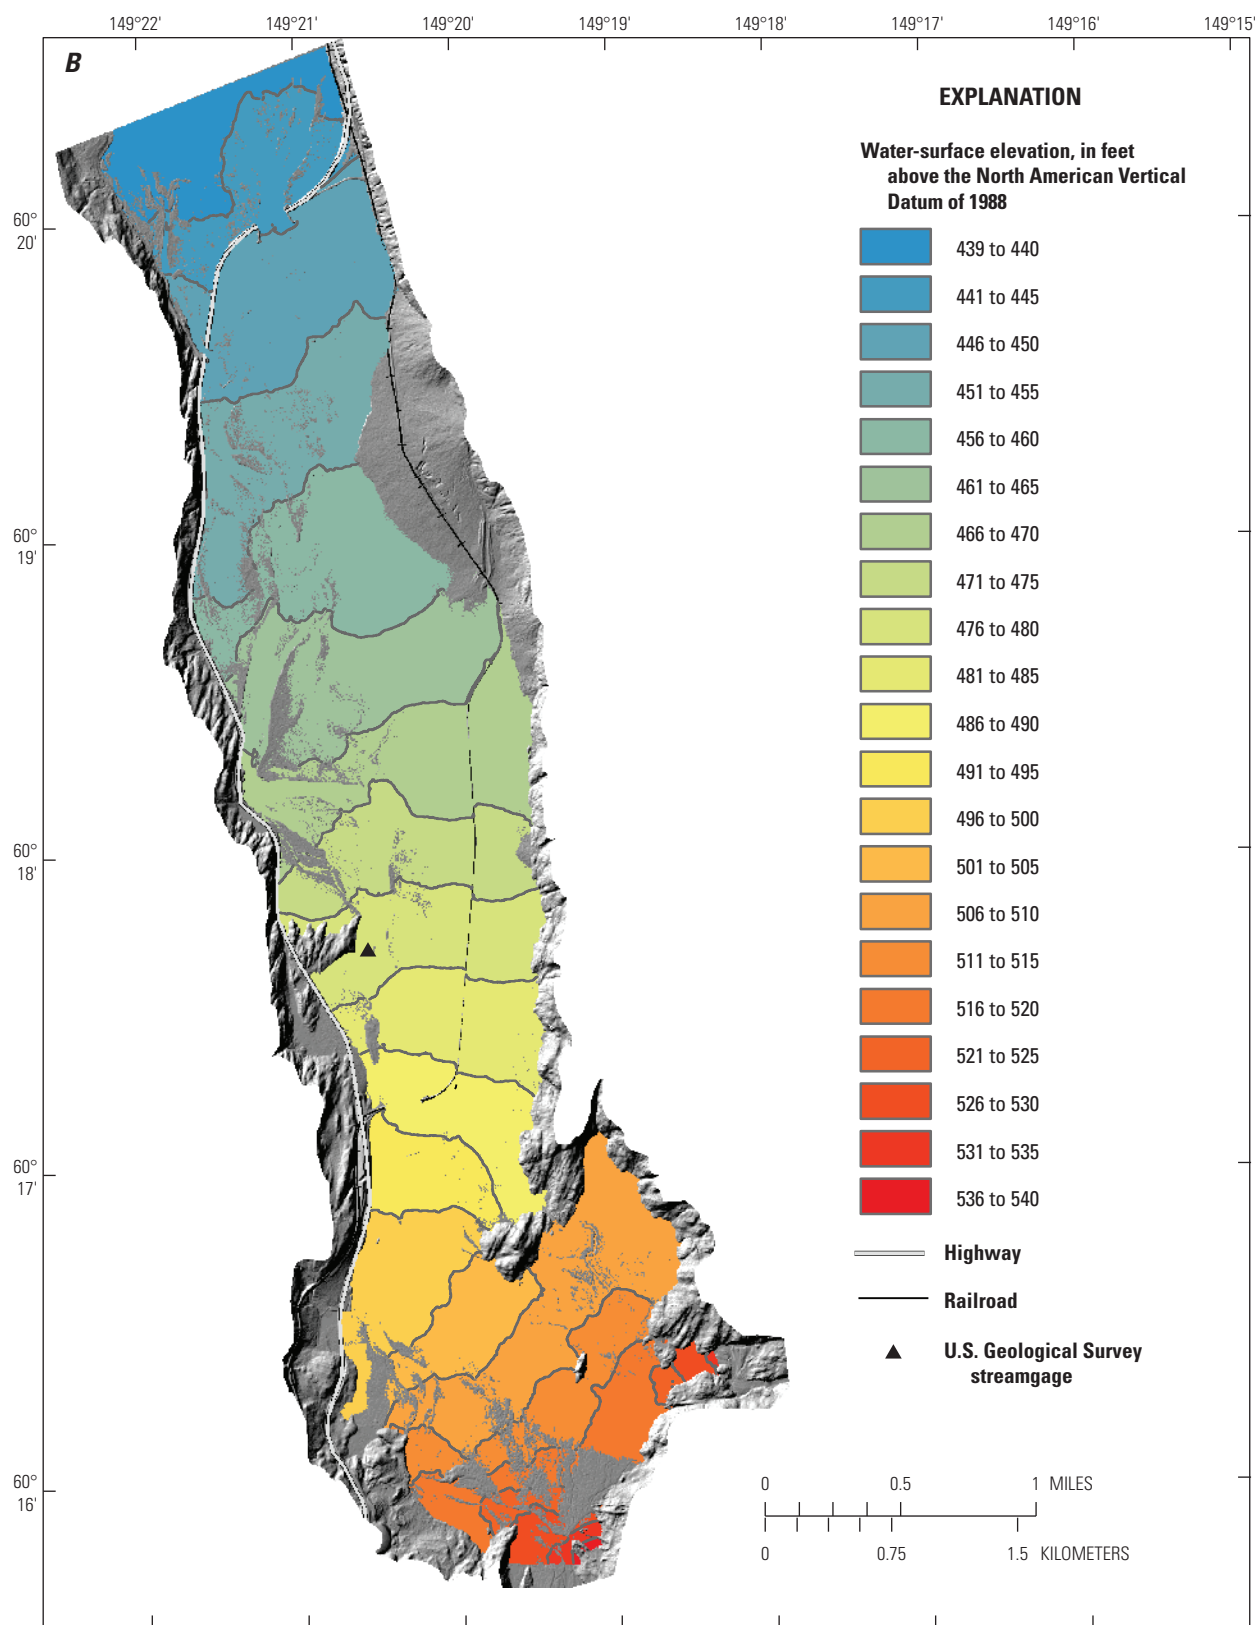
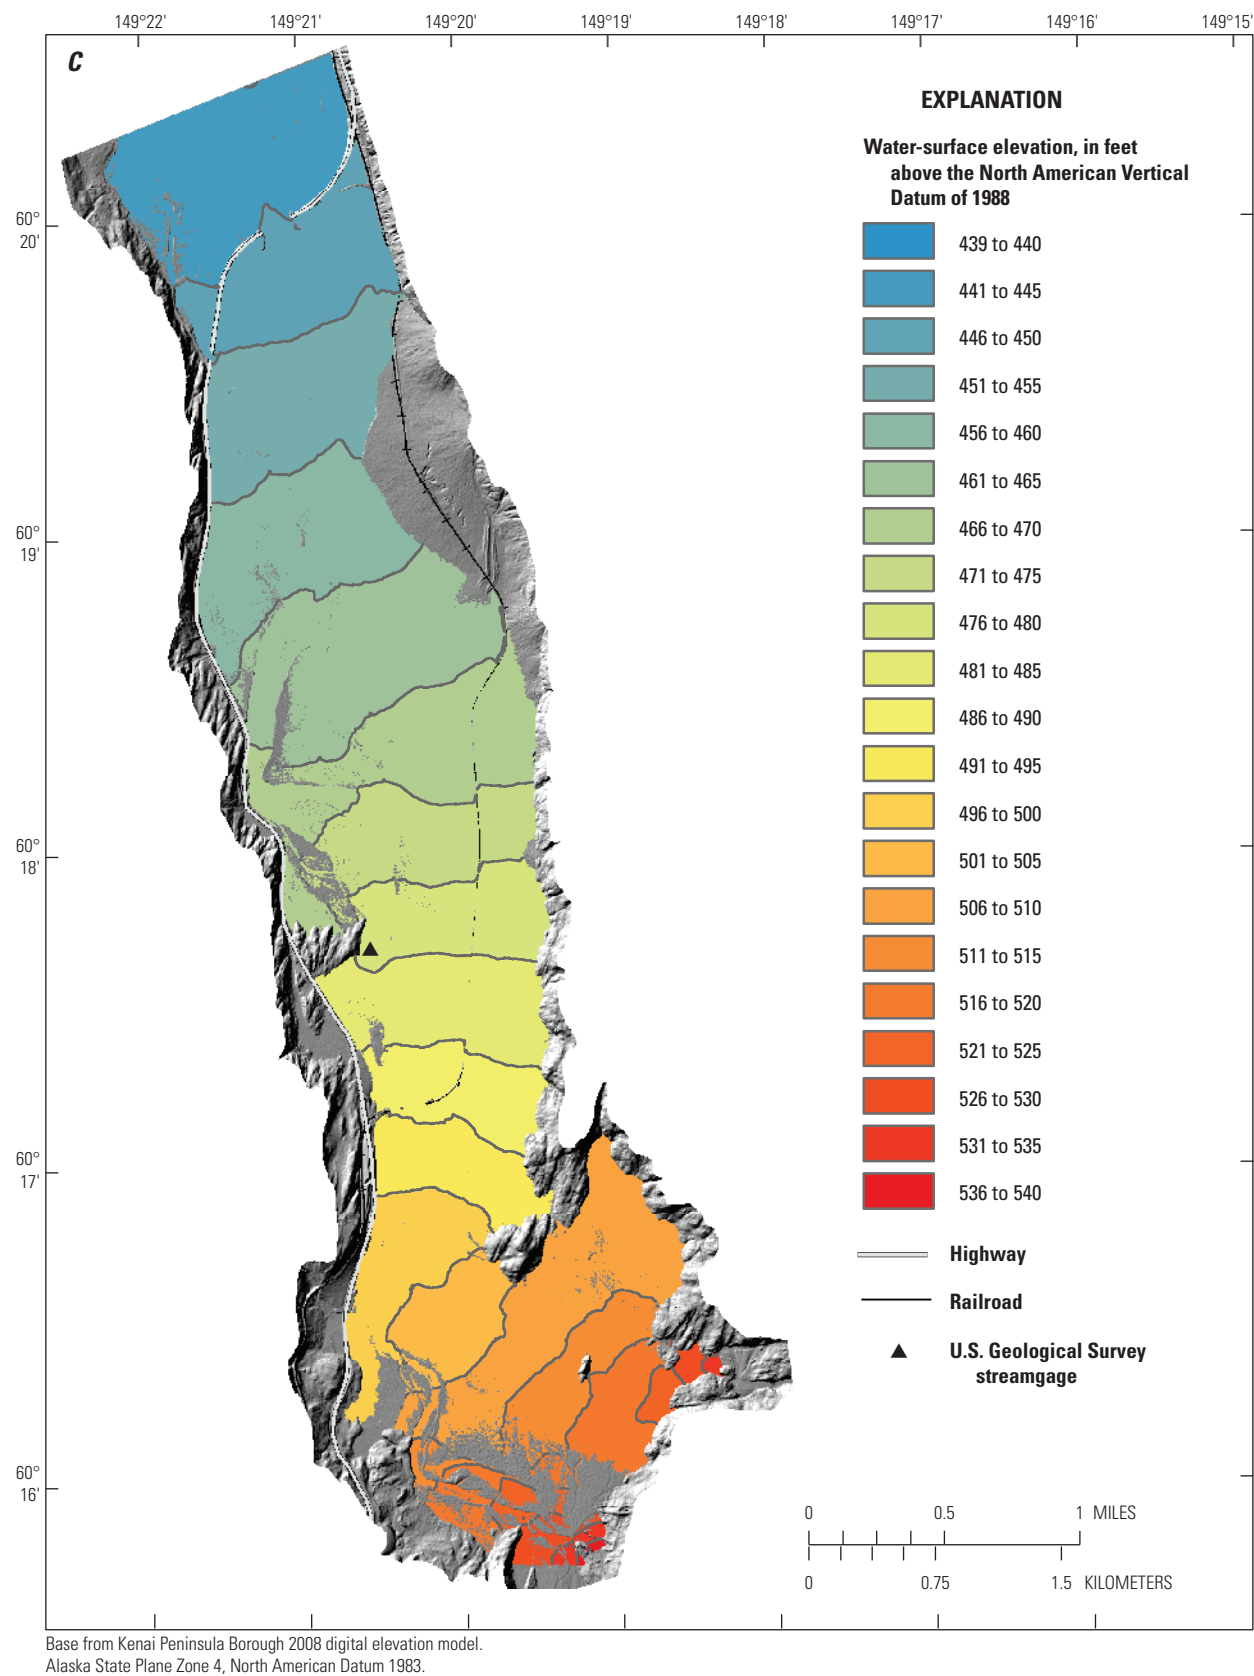
Figure 19. SRH-2D simulation water-surface elevations and inundation extent for flood flows of (A) 18,900, (B) 28,800, (C) 43,600, and (D) 60,000 cubic feet per second, near Seward, Alaska.

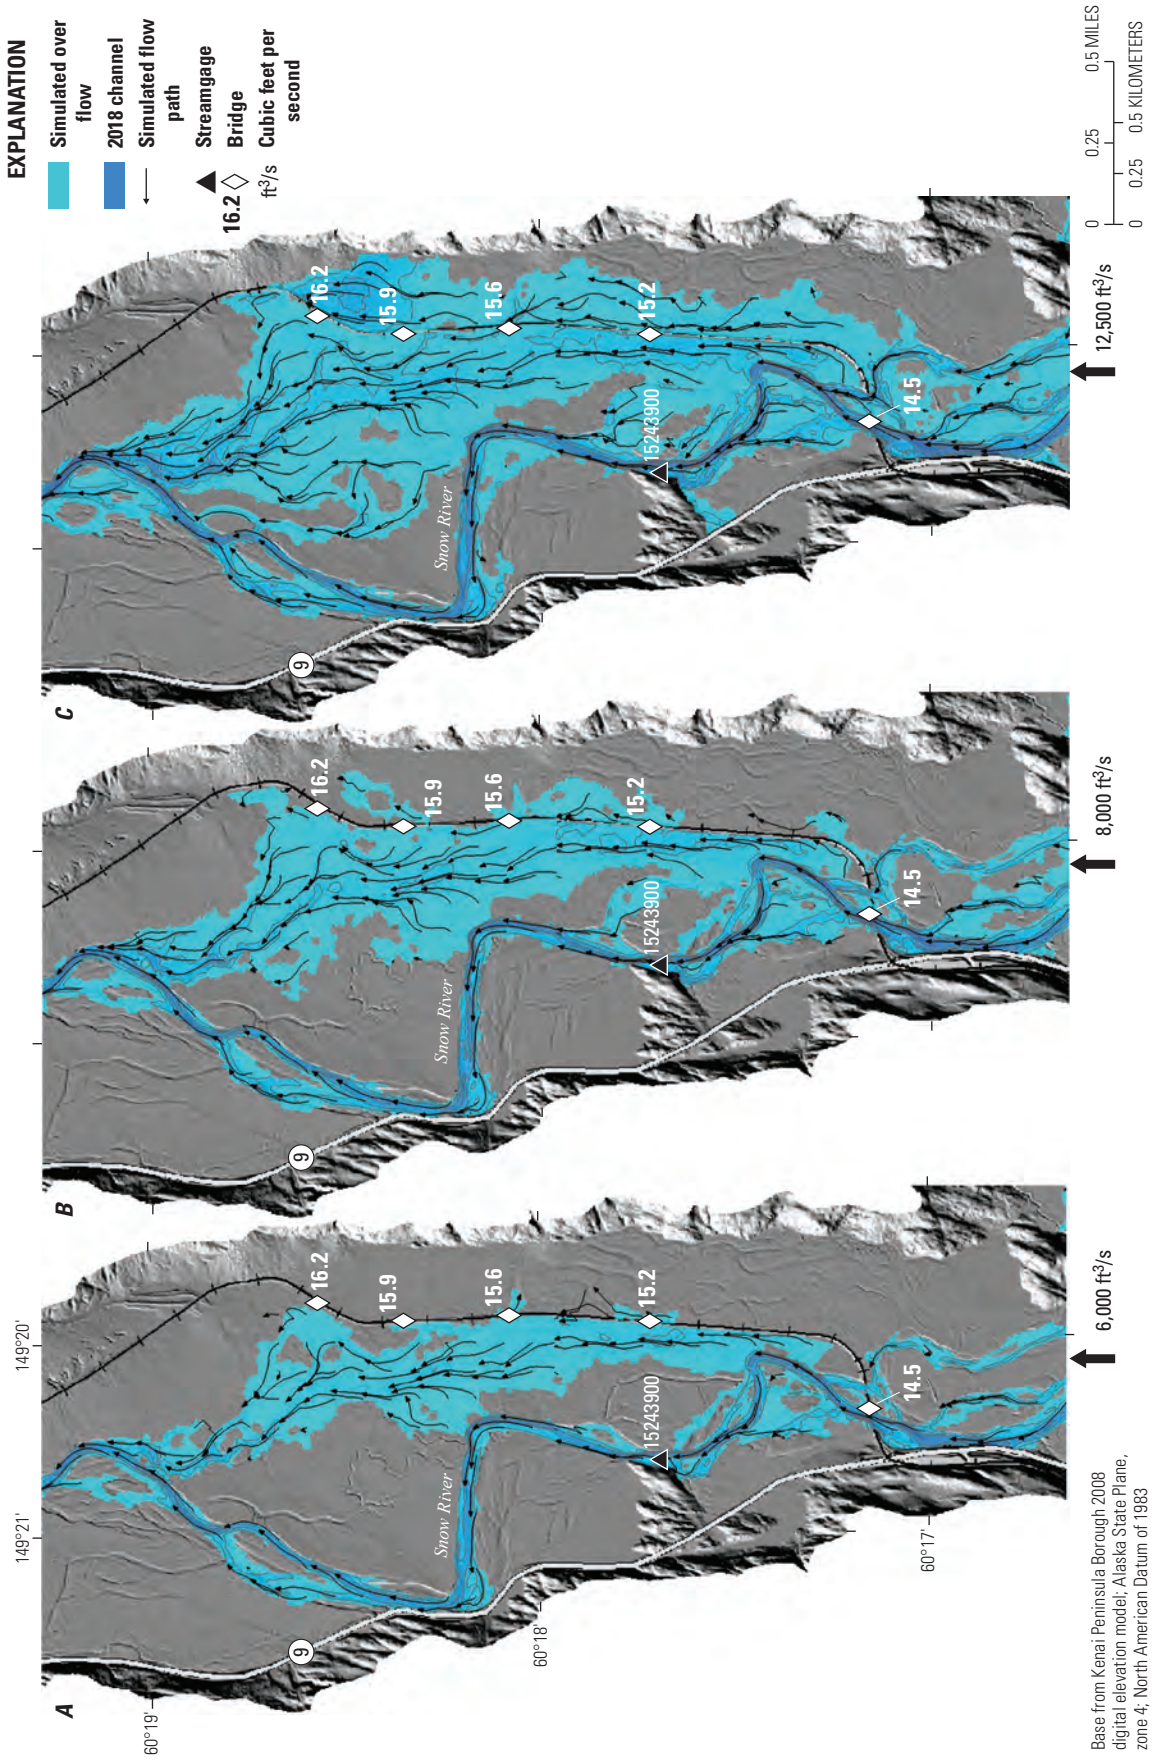
Figure 20. Simulated overflow from main channel toward rail embankment during the rising limb of the outburst flood for flows of (A) 6,000, (B) 8,000, and (C) 12,500 cubic feet per second, near Seward, Alaska.

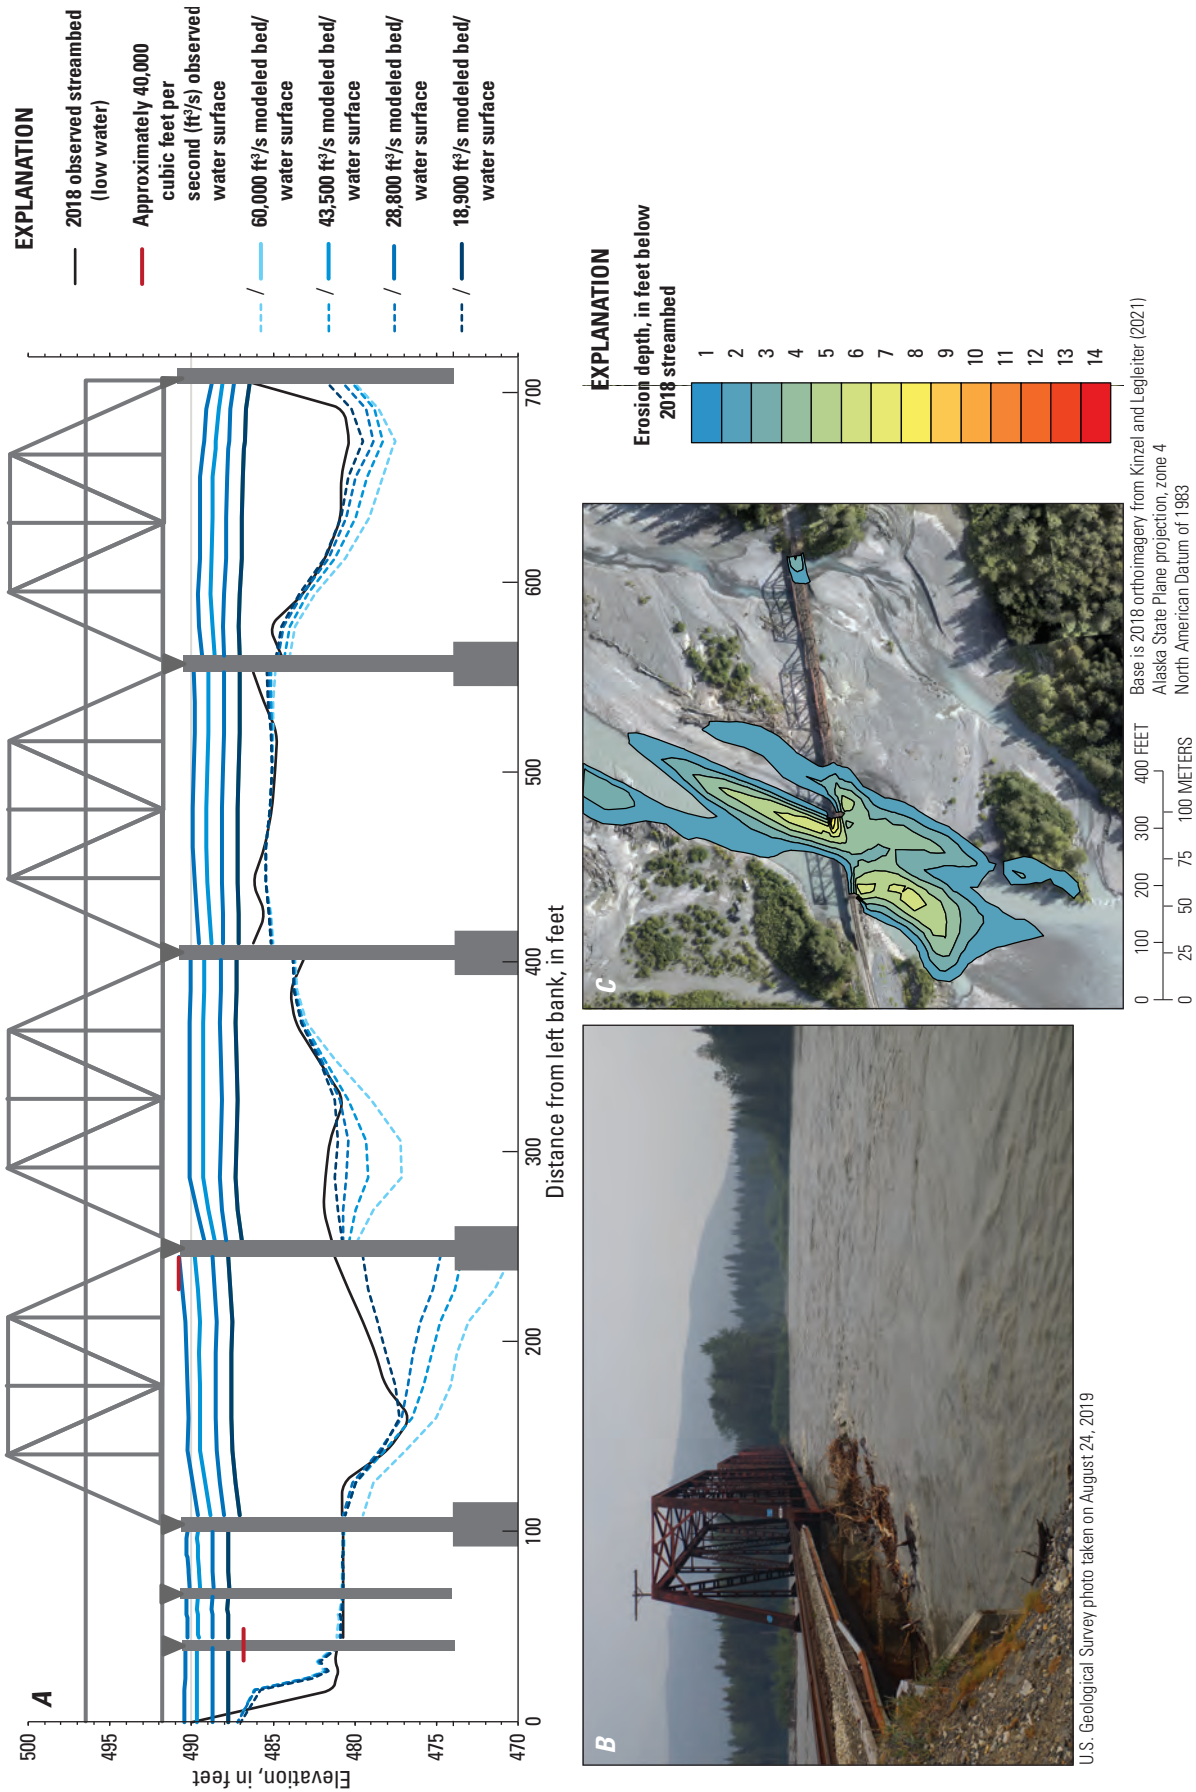
Figure 21. (A) Model results and measured water surfaces, (B) flood peak on August 24, 2019, and (C) scour as simulated by SRH-2D (Lai, 2008), at Bridge 14.5, Snow River near Seward, Alaska. Photograph taken by U.S. Geological Survey.

(fig. 21). Model simulations show higher water surfaces at the left side of the bridge compared to observations. The blocking of piers with woody debris (fig. 14), not simulated in the model, may locally raise water levels at the bridge. Sediment transport simulations show flow skewed to the bridge opening and scour predominantly on the left bank side of piers. This is consistent with the flow pattern observed during floods. The lowest measured point on the cross-section in 2018 is 477 ft, while the lowest modeled point on the cross-section during the peak of the 2019 flood is 473.4 ft, just below the top of footing elevation of 474 ft. As described above, an increasing percentage of flow bypasses the railroad bridge to the east and flows behind the railroad tracks. If bypass flow is redirected through the bridge with engineering structures or as a result of channel change, both scour and water-surface elevation would increase.

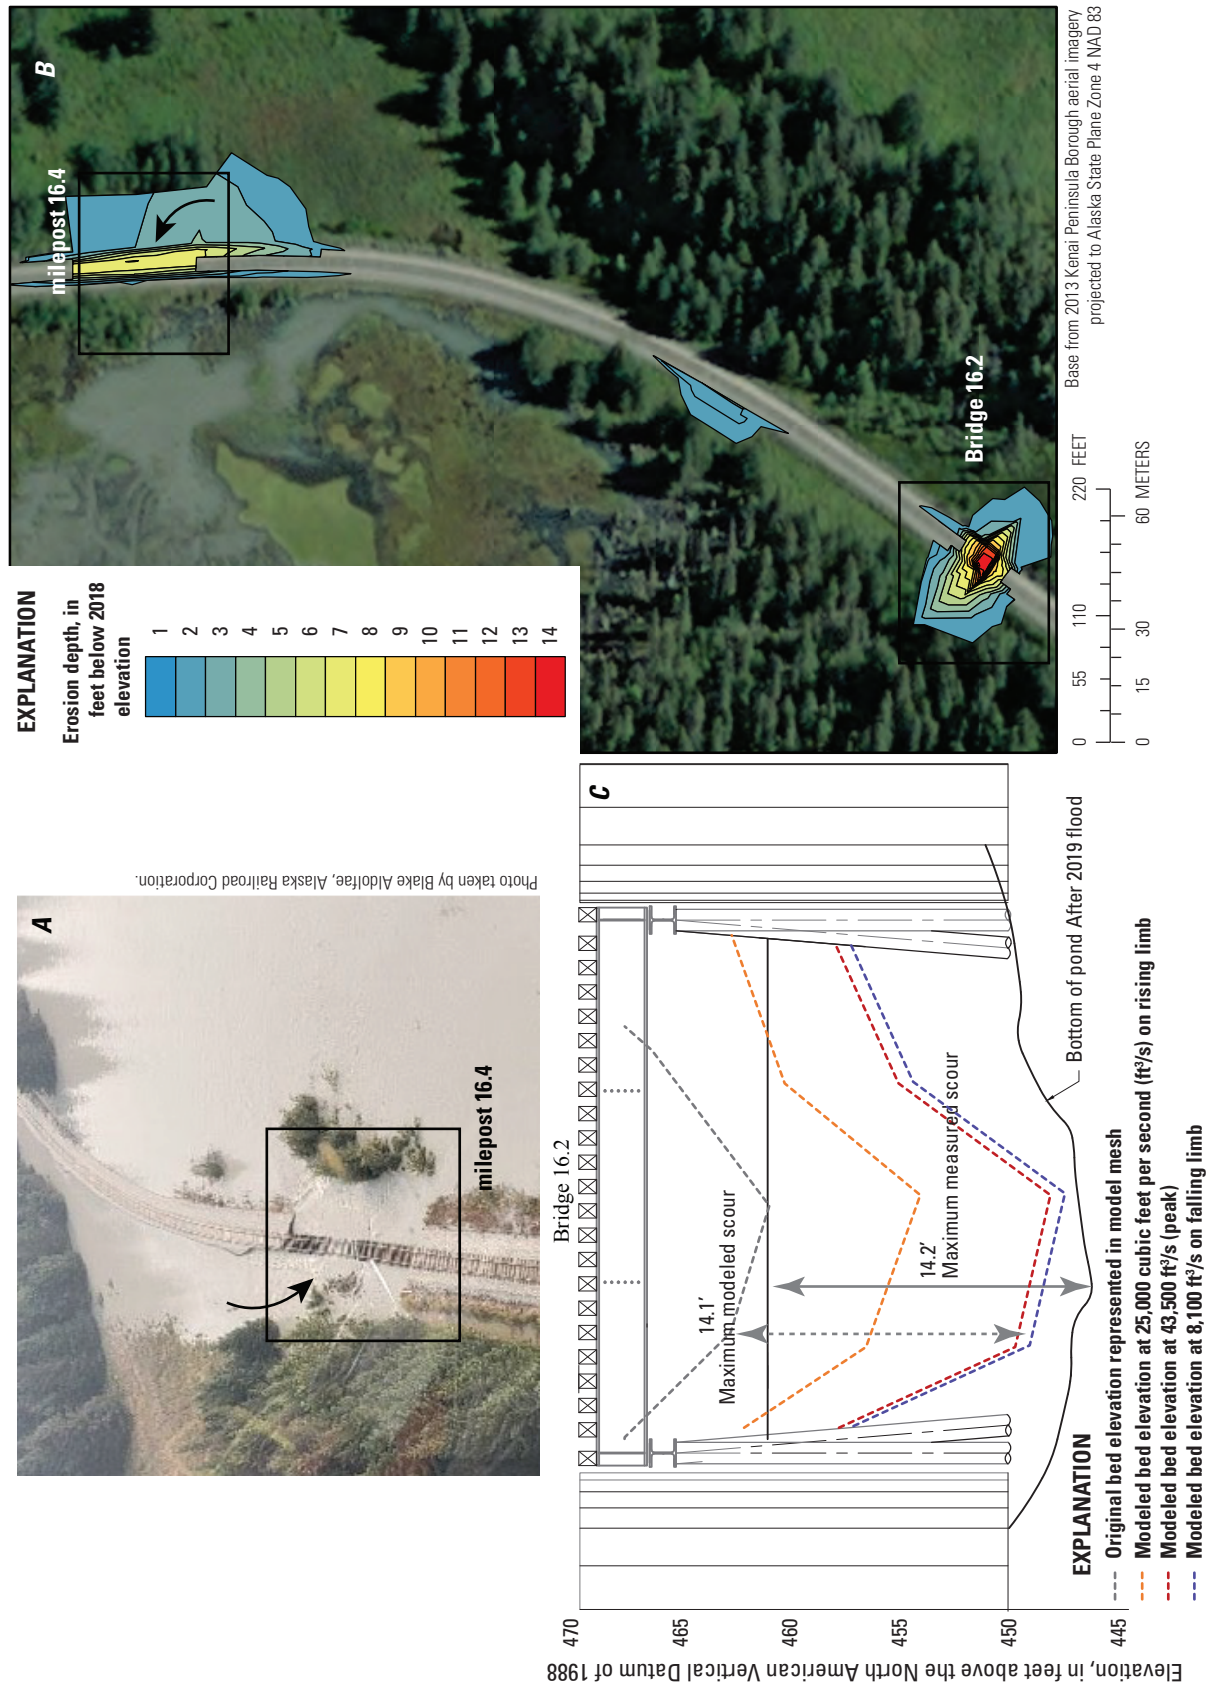
Figure 22. (A) Fill loss around MP 16.4, (B) scour as simulated by SRH-2D (Lai, 2008) from MP 16.2 to 16.4, and (C) Bridge 16.2 with measured post-flood scour and simulated scour, near Seward, Alaska.

Simulating flood inundation and flood damage potential along the railroad grade was one of the primary goals of the SRH-2D modeling. The 2019 flood model simulated approximately 14 ft of scour at Bridge 16.2, as well as up to 6 ft of fill loss where the grade was overtopped at MP 16.4 (fig. 22) and up to 2 ft of fill loss at MP 15. Fill loss was not documented post-flood at MP 16.4. Photographs at MP 15 suggest up to 3 ft of fill loss (fig. 7).
